## SOP for GOES ABI Image Stripping

GOES-R CWG

2020-04-xx

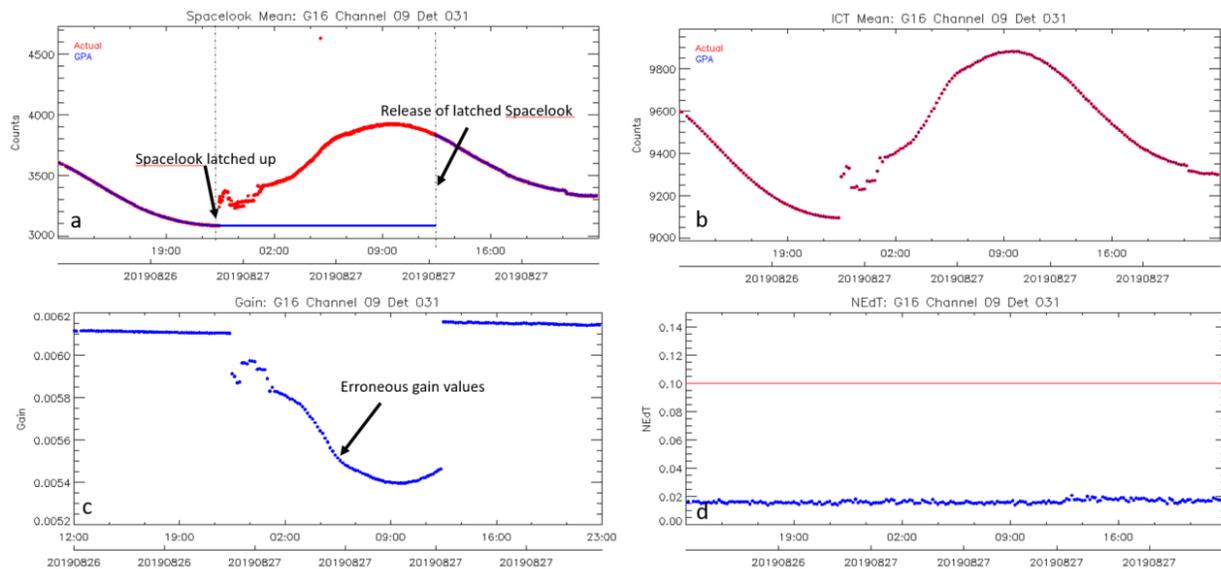
Throughout the mission life, well-characterized detector may change over time in several ways. Sometimes, a detector's response to signals changes (increases) suddenly (Fig. 1). This is normal, often referred to as "level shift", and is likely due to change in dark current. Level shift usually does not affect detector performance. For example, the noise in terms of Noise Equivalent differential Temperature (NEdT) remains normal before and after the level shift. However, a flawed algorithm to reject lunar contamination may misidentify the sudden space count increase as lunar intrusion. In response, the Ground Processing Algorithm (GPA) uses the space count just

before the level shift. This creates a “latch up” of space count that ignores future change of space count and leads to incorrectly calibrated radiance and stripes in image. Note that the Internal Calibration Target (ICT) count is not subject to lunar intrusion and therefore does not latch up after level shift. Depending on the magnitude and timing, latch up can be self-released by diurnal variation of space counts, or require operator intervention. Before the space count latch up can be eliminated by a more sophisticated lunar contamination rejection algorithm, satellite operator must manually release some of them as soon as it is found.

**Figure 1: Time-series of space count (a), ICT count (b), gain (c), and NEdT (d) during an episode of space count latch up of GOES-16 Channel 9 Detector #31 on August 26-27, 2019. The red symbols in (a) & (b) are the ABI measurements, which show a level shift for both space and ICT counts at 2230 UTC on August 26. The blue symbols in all panels are values derived and used by GPA, for which the space count in (a) latched (remained constant) after level shift but the ICT count in (b) did not. This resulted in erroneous gain in (c) that caused a relatively colder line in every swath of images (image striping). At 1226 UTC on August 27, the space count was manually reset to its correct value, which released the latch up and resumed normal calibration. Note that the detector noise in (d) had been stable and well within the requirement throughout the scenario.**

1. Identify the offending detector(s).
2. If the offending detector is latched up after a level shift (ref. Fig. 1), recommend a manual release of the latch up.

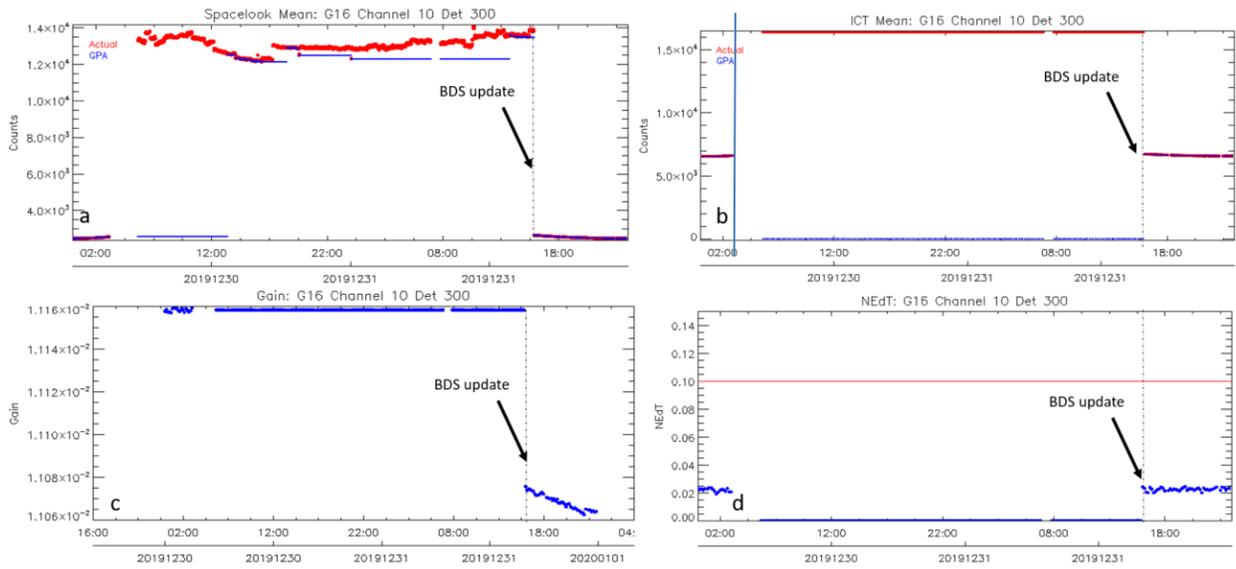
Figure 2: Similar as Figure 1, but during an episode of ICT saturation of GOES-16 Channel 10 Detector 300 on December 30-31, 2019. The SPL count was not saturated, yet experienced several human interventions to release the latched SPL count (a). The ICT count for this detector was saturated between ~0400 UTC on December 30 to ~1600 UTC on December 31, when GPA set the ICT count to zero. (b) Normal calibration resumed after a “BDS update” replaced the degraded detector.

4. If the ICT (or space – for Channels 13-16) count of the offending detector is saturated (ref. Fig. 2), recommend a BDS update. In this context, a detector is saturated if its daily maximum is within three times of the standard deviation of the counts. The standard deviation is computed as in “3a”.

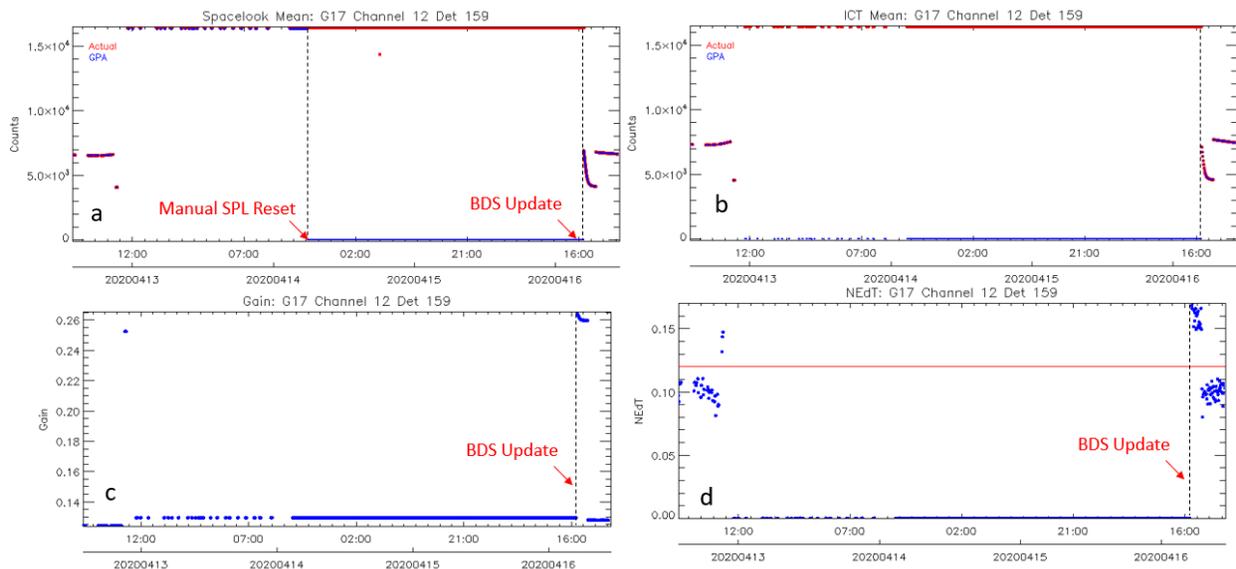
Figure 3. Similar as Figure 2, but during an episode of saturated SPL and ICT counts for G17 B12 Det#159 between 16:25 UTC on 04/13/2020 and 16:56 UTC on 04/16/2020. In the GPA processing, the SPL count was latched-up at a value before the saturation. A manual space-look reset was conducted around 17:54 UTC on 04/14/2020, resulting the GPA SPL set to zero (a). The zero SPL forced the resampling algorithm to skip this detector to mitigate

the strong striping caused by the detector saturation. As the ICT saturated, GPA does not calculate ICT count, gain and NEdT values, resulting in zero value for these parameters in this case (b, c and d). Normal calibration resumed after the “BDS update”.

- a. If the space-look count of the offending detector is saturated (Fig 3. A), recommendation of manual reset of the space-look while preparing for the BDS update. This manual SPL reset will not be needed once the long-term fix of the lunar-intrusion algorithm is operationally implemented.

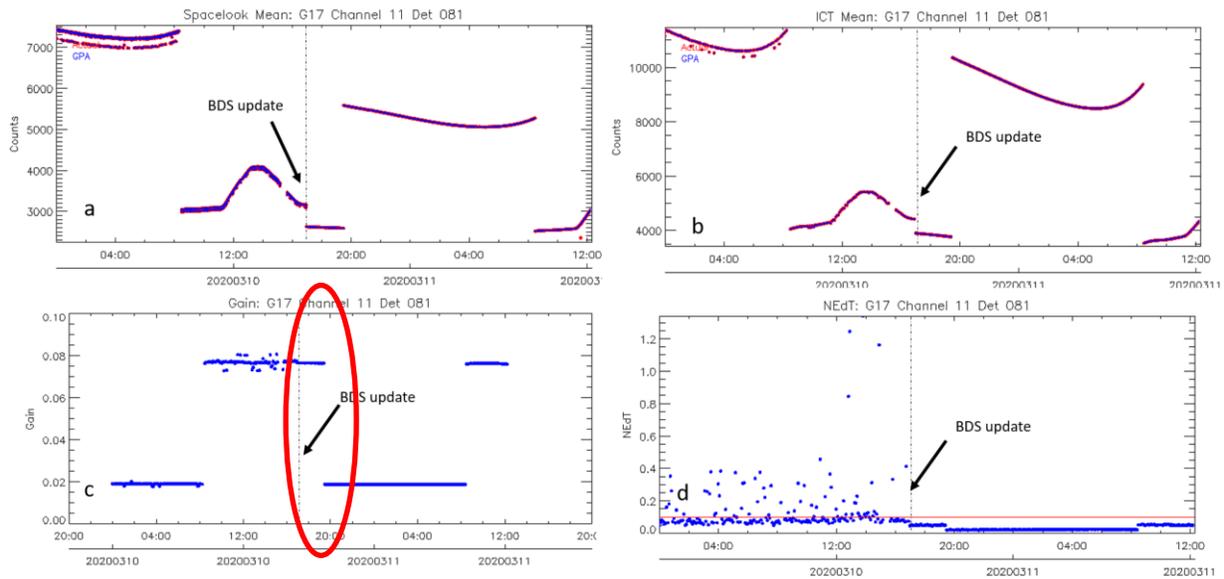
Figure 4: Similar as Figure 2, but during an episode of elevated detector noise and gain instability of GOES-17 Channel 11 Detector 81 that ended on March 10, 2020. The noise often exceeded the requirement marked by a red line in (d); the space count in (a) and ICT count in (b) were nearly bimodal; and the gain in (c) was unstable. This led to intermittent image striping. Normal calibration resumed after a “BDS update” replaced the degraded detector.

3. If the gain of the offending detector is unstable, recommend a BDS update. In this context, the gain is unstable if
  - a. Its standard deviation is **five** times larger than its normal value for at least **one** hour (ref. Fig. 3c & 4c). To compute the standard deviation, remember that gain may have diurnal variation that must be properly accounted for. This also requires computing and archiving the normal value of standard deviation for each detector when it is stable.

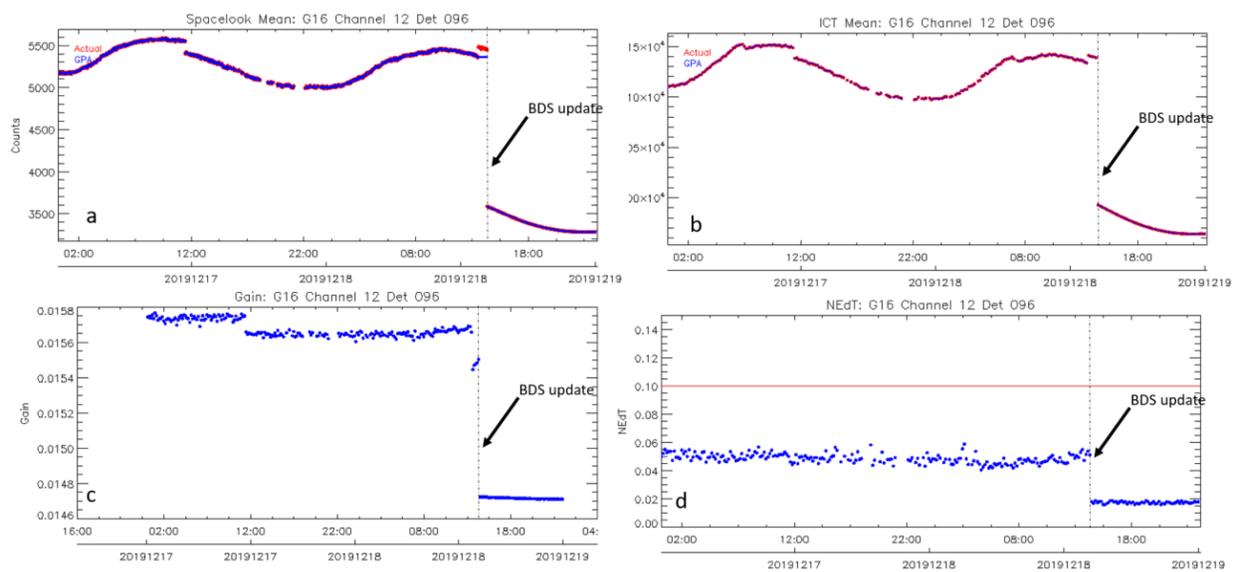
Figure 5: Similar as Figure 3, but during an episode of elevated gain instability of GOES-16 Channel 12 Detector 96 that ended on December 18, 2019. The noise in (d), though meet the requirement, was higher and less stable than usual; and the gain in (c) was unstable. This led to intermittent image striping. Normal calibration resumed after a “BDS update” replaced the degraded detector.
