SNPP ICVS Annual Review: 20150508

SNPP CrIS Instrument Performance

- Part 2: SNPP/CrIS Instrument Performance

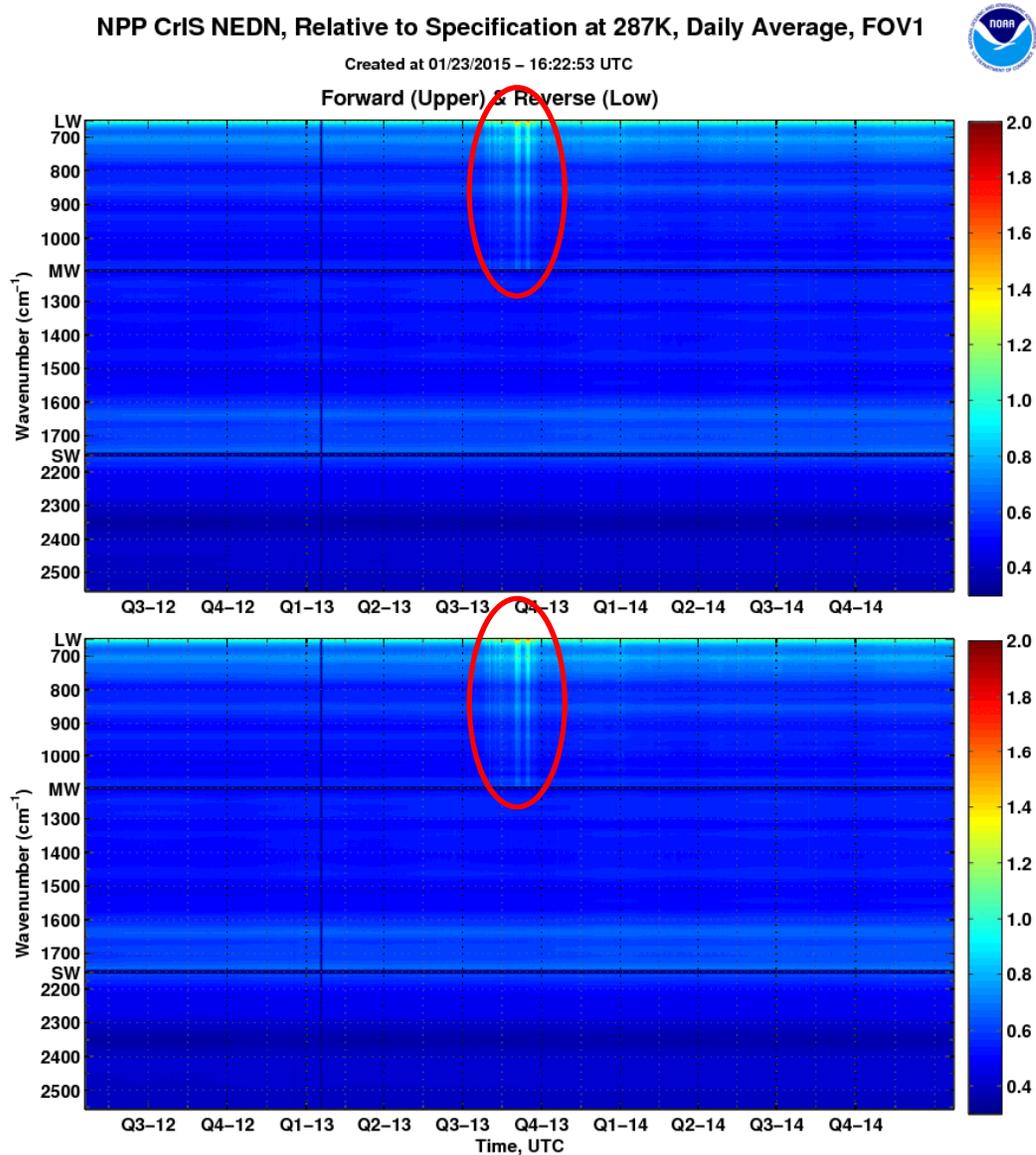
Hardware anomaly: LW NEDN

- LW FOV1 spectral noise anomaly between July and September of 2013

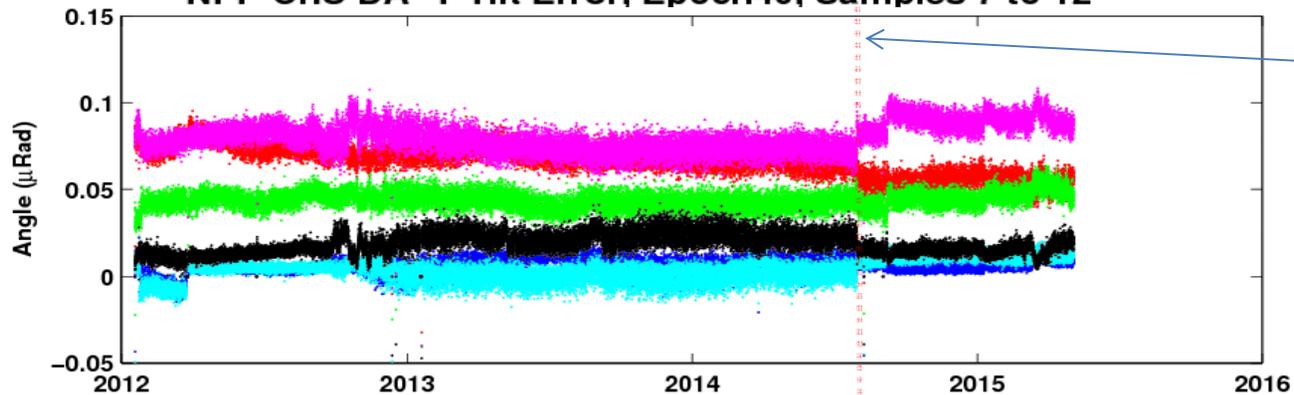
NPP CrIS DA-Y Tilt Error, Epoch40, Samples 7 to 12

Hardware anomaly: DA Mirror Tilt Error

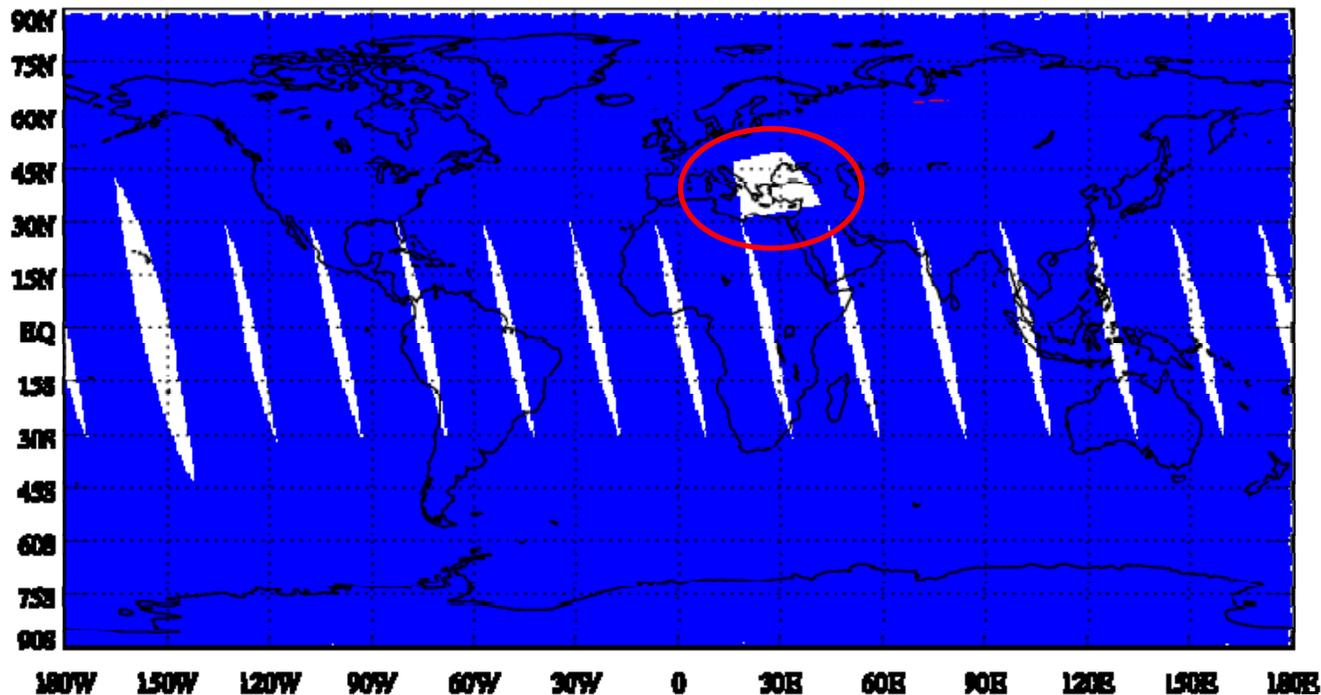
NPP CrIS FSR SW SDR Overall Quality Flag, Mapped, Ascending, 03/17/2015
(Blue: Good; Green: Degraded; Red: Invalid) Updated at Mar 18 18:14:29 2015 UTC

- Scene select module position counter error
 - FOR position is lost and the whole 30 scans in the sliding window containing this FOR are skipped without processing. When the SSM servo motor ages, this type of anomaly could happens more frequently

To be fixed in DR 7571:
Set the contaminated scan as missing

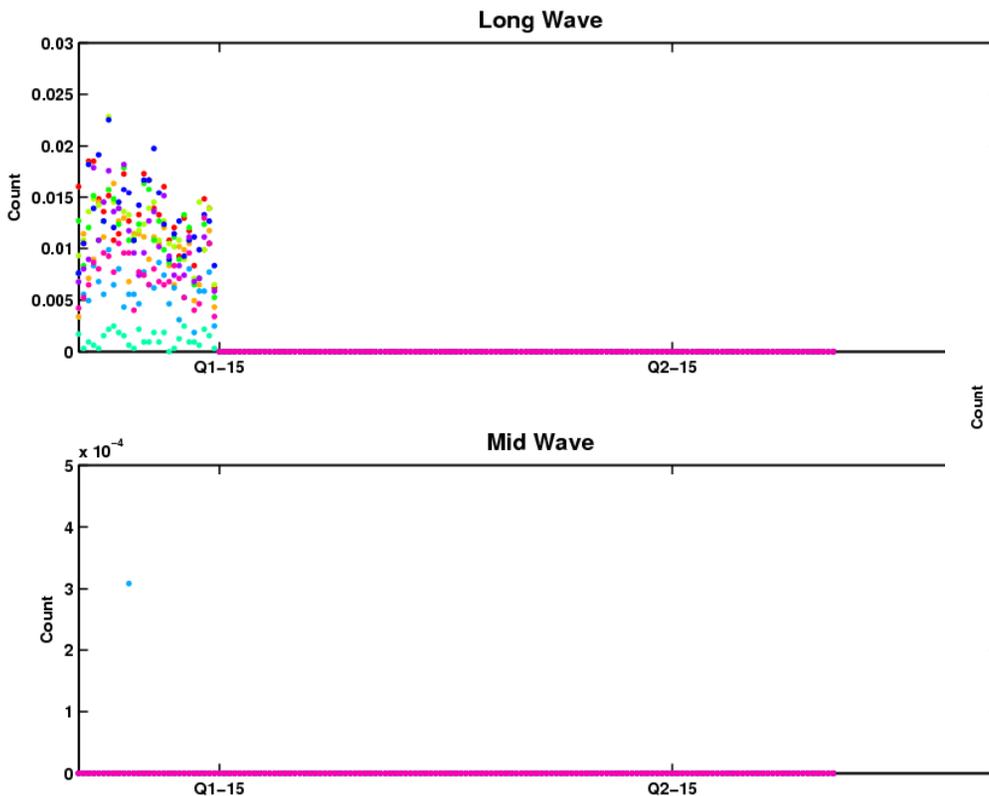
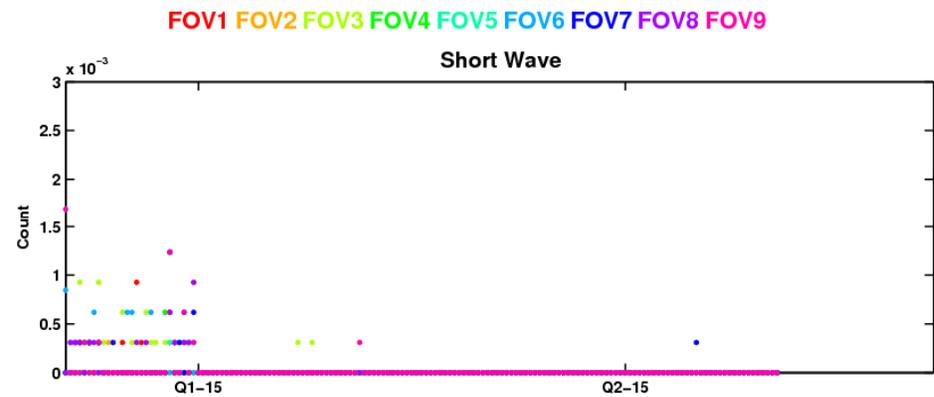
NPP CrIS FSR Raw Data Record Impulse Noise Count, Daily Average
Created at 05/04/2015 – 04:04:44 UTC

- Happened in December 2014 after switching to full-resolution mode by implementing new bit-trim mask and new impulse noise mask
- Root cause: residual signal hit the impulse noise mask after switching from a hot scene to a cold scene
- Fixed on Dec 31, 2014 after implementing a wide open impulse noise mask

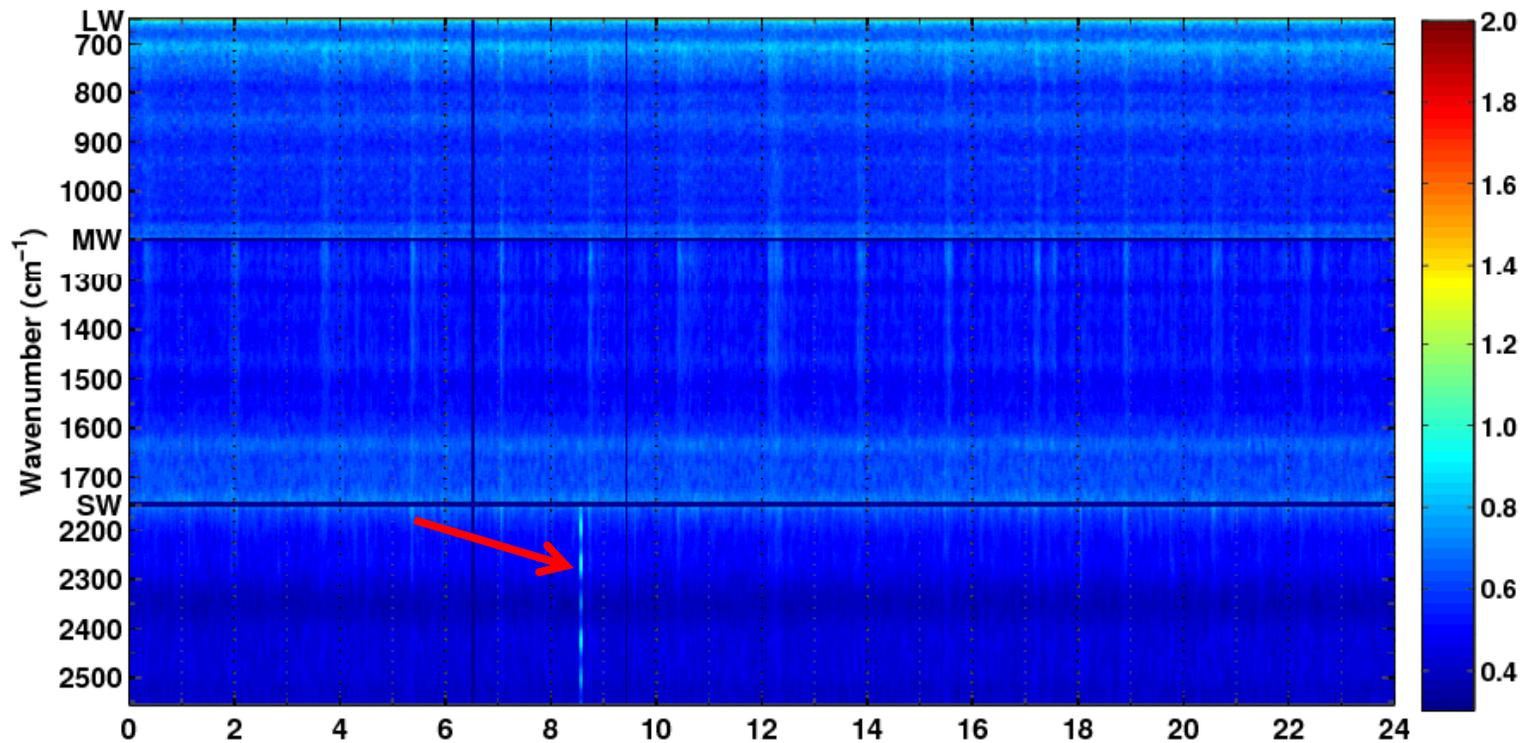
NPP CrIS NEDN, Relative to Specification at 287K, FOV6: 2014/01/09

- Impulse noise occasionally seen on ICT scene

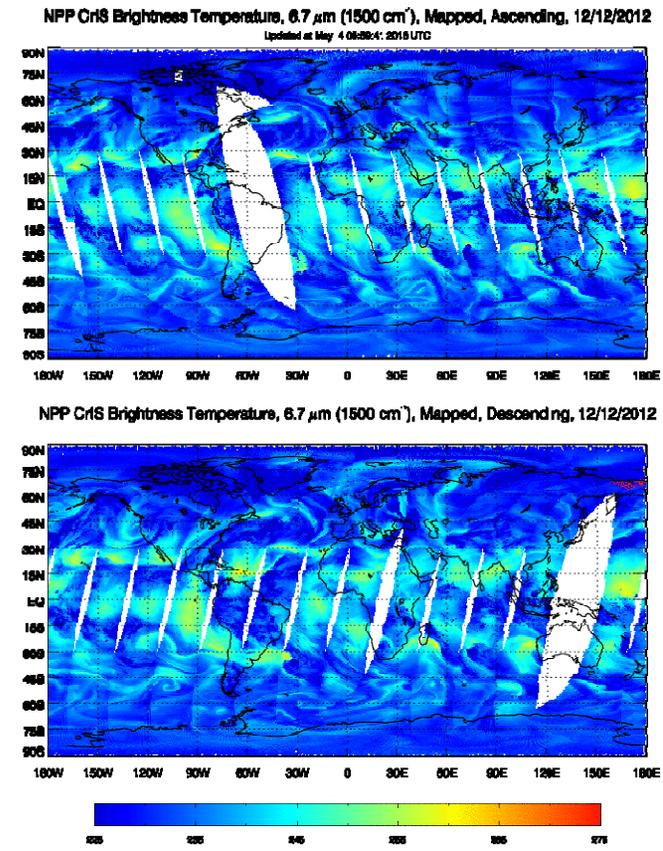
- Description:
 - CREECBIT, aka, Single Bit Error Correction Control Error
 - Single bit error: Value of a single bit in the onboard computer memory is shifted unexpectedly
 - Occurred several times since launch
- Root cause:
 - Cosmic rays or chip flaws
- Solution:
 - Re-start the system
- Impact:
 - Losing data permanently
- Mitigation:
 - Report it as soon as possible

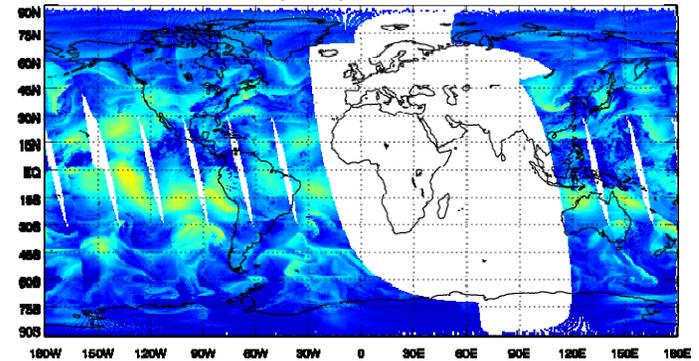
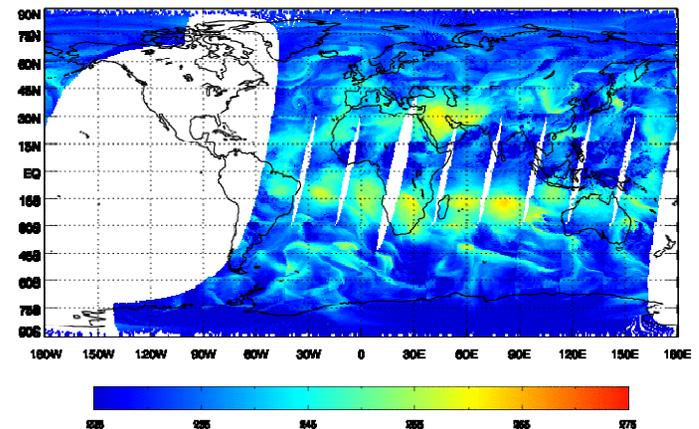
NPP CrIS Brightness Temperature, 6.7 μm (1500 cm^{-1}), Mapped, Ascending, 09/02/2014
Updated at Sep 02 02:28:09 2014 UTC

- Description:
 - The state of any node changed
 - Occurred several times since launch
- Root cause:
 - Cosmic rays
- Solution:
 - Re-start the system
- Impact:
 - Losing data permanently
- Mitigation:
 - Report it as soon as possible

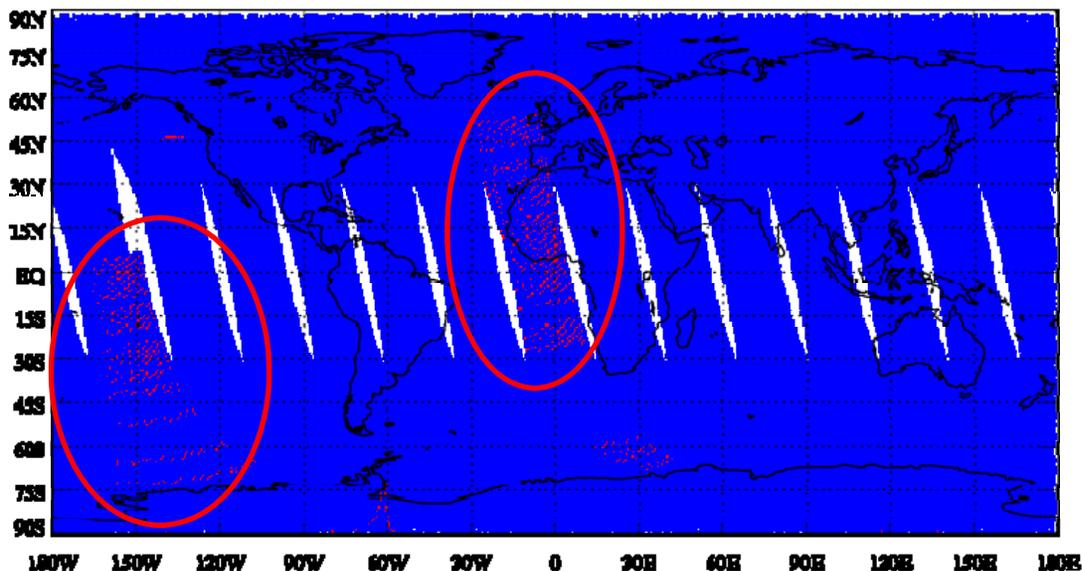
NPP CrIS FSR MW SDR Overall Quality Flag, Mapped, Ascending, 02/09/2015
(Blue: Good; Green: Degraded; Red: Invalid) Updated at Mar 12 23:03:30 2015 UTC

- Description:
 - FOV4 data packets were missing since CrIS is in full-spectral resolution mode
- Root cause:
 - IDPS RDR data stream contaminated by the Direct Broadcasting (DB) data stream which intentionally dropped FOV4 for data rate concern.
- Impact:
 - losing data in IDPS operational SDR products
- Solution:
 - Fixed? Not seen since April 2015

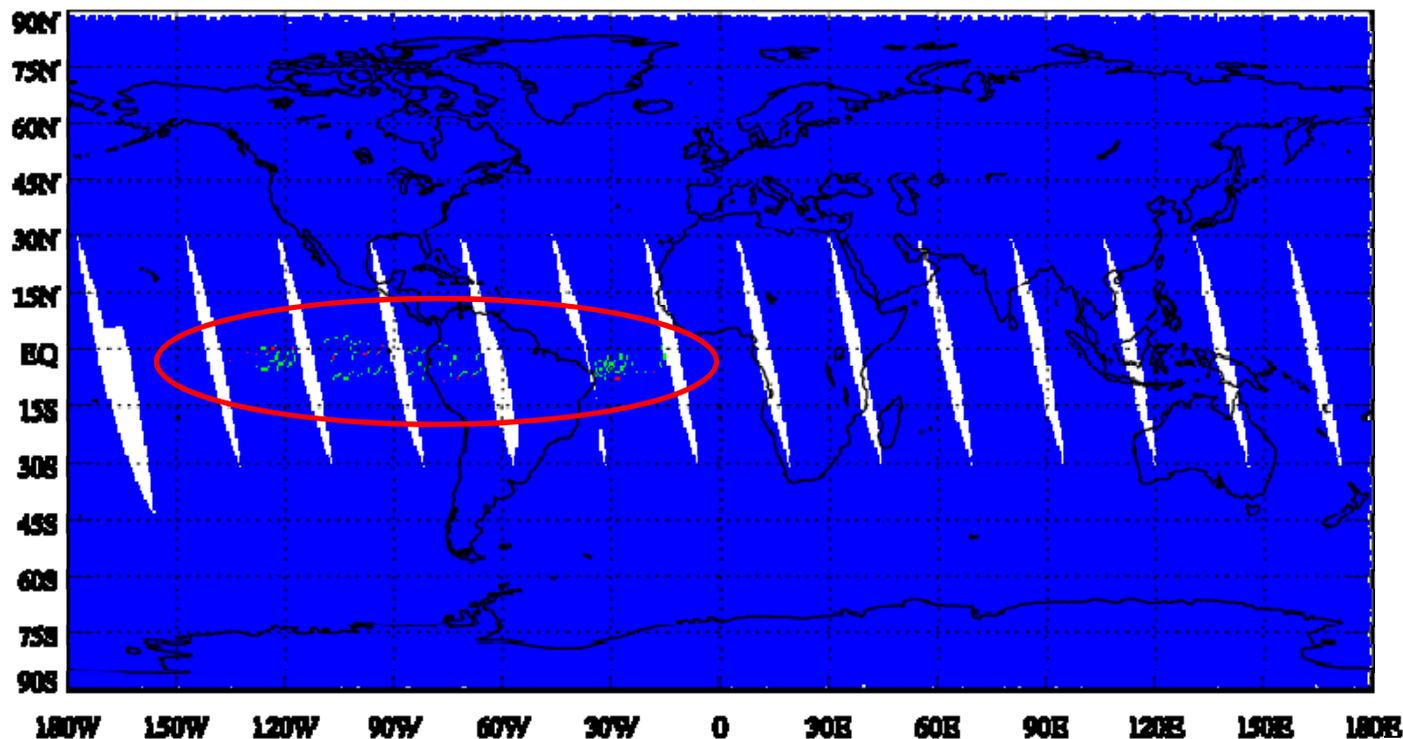
NPP CrIS FSR SW SDR Overall Quality Flag, Mapped, Ascending, 03/30/2015
(Blue: Good; Green: Degraded; Red: Invalid) Updated at Apr 4 13:39:24 2015 UTC

- The lunar event detection threshold is not updated accordingly in the FSR SDR algorithm, resulting in overdropping of valid calibration scene.
